National Dam Inspection Program. Wild  
Creek Dam, Carbon County, Pennsylvania  
(National I.D. Number PA-00609),  
Delaware River Basin, Wild Creek, Carbon  
County, Pennsylvania,

Phase I Inspection Report,

WILD CREEK DAM  
CARBON COUNTY, PENNSYLVANIA  
NATIONAL I.D. NO. PA 00609

## PHASE I INSPECTION REPORT NATIONAL DAM INSPECTION PROGRAM

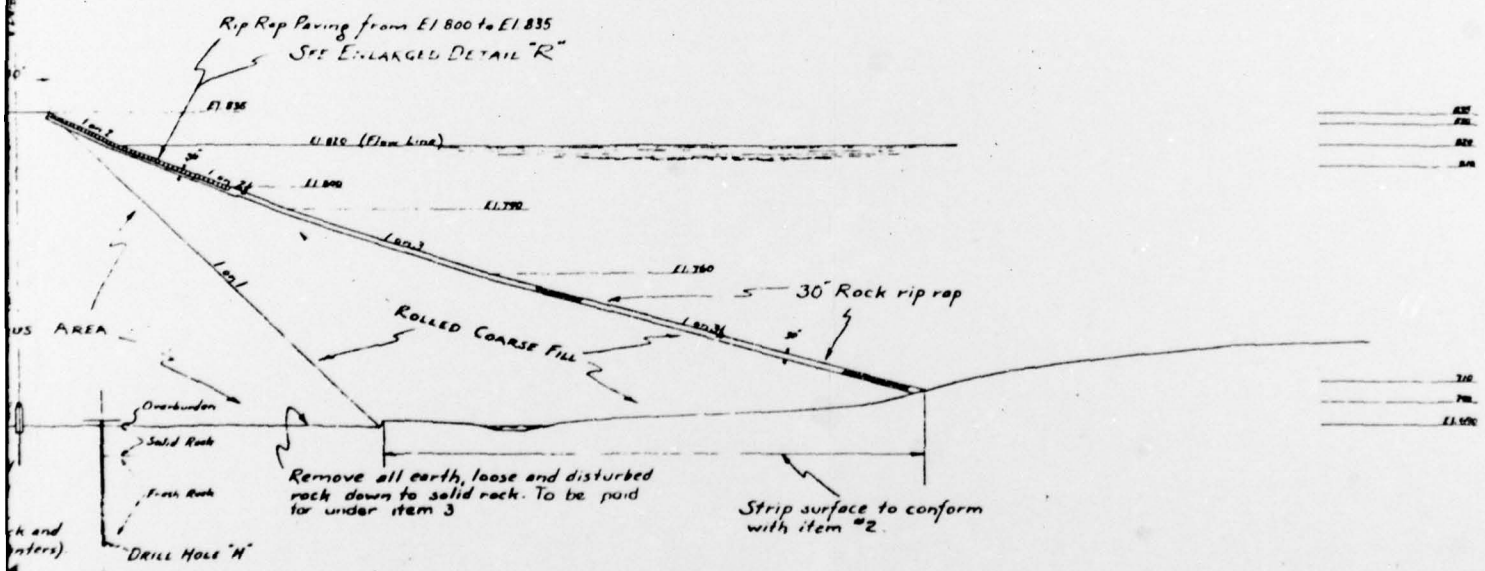
TYPICAL DESIGN EMBANKMENT WILD CREEK DAM		
NAT. ID NO. PA. 00609		CARBON COUNTY
DATA OBTAINED FROM DESIGN DRAWINGS CONTRACT NO. 5, SHEET 7, DATED MARCH 1, 1939		
		PLATE 3

The central clay core is encased in a rolled coarse fill without a transition filter or drainage system. The upstream slope is protected with an additional three feet of approximately 12-inch rock over a six inch sand and gravel bedding. The upstream varies in inclination from 2H:1V from the crest to elevation 820 to 2½H:1V from elevation 820 to 790 to 3H:1V from elevation 790 to elevation 760 and 3½H:1V below elevation 760. Downstream the slope varies from 2H:1V between elevation 835 and 805 to 2½H:1V from elevation 805 to 765 and 3H:1V below elevation 765. Reportedly, there is a downstream toe drain as shown on Plate 3.

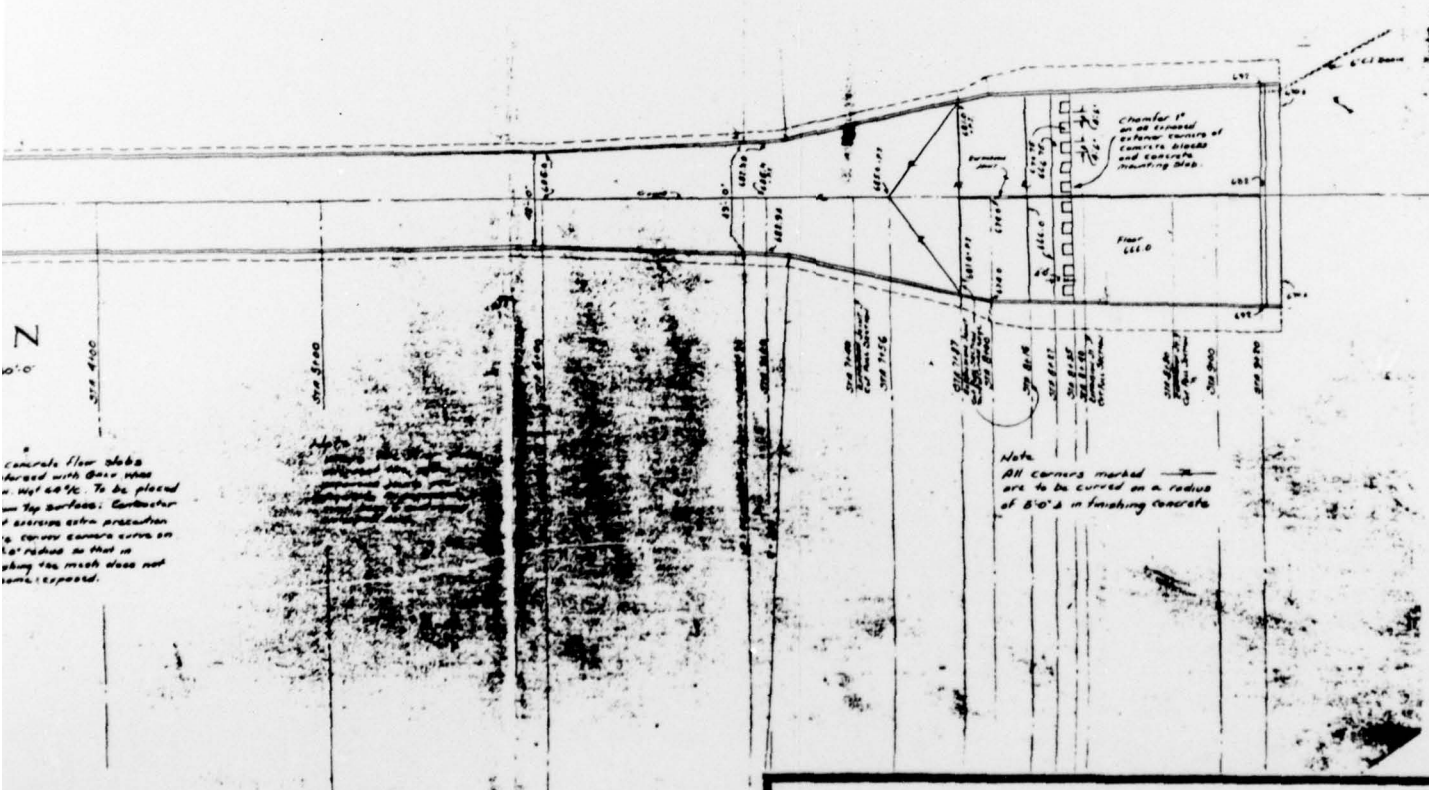
PLATE 4

A reinforced concrete spillway with a crest elevation of 820 is located in the right abutment of the dam. The hydraulic parameters of the spillway are discussed in Section 5 below. The design drawings identify the spillway walls to be basically of a cantilevered design with walls of uniform thickness. The stilling basin discharges into the original course of Wild Creek. Plate 2 shows the original spillway design which was changed, after a series of model studies were performed, to the configuration shown on Plate 4.
